# The Croft Farm Barn

Llanvetherine, Monmouthshire NP7 8RA

A restoration project by the **Village Alive Trust**  
**Ymddiriedolaeth Y Pentre Byw**

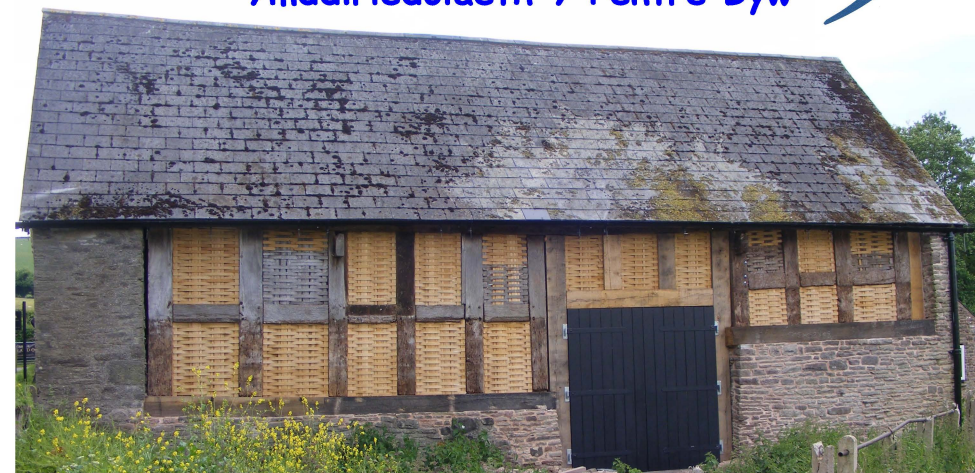
The Grade II\* Listed **Croft Barn**, which was built in the early 1580s as a five-bay corn barn, has seen remarkably few changes over the years. The fine carpentry of the cruck trusses can still be seen today along with several pieces of the original un-daubed oak splitlath panels which fill the window spaces. But more than 400 years of use and of weather took a toll, and by 2012 when *The Village Alive Trust* was approached by its owners, the barn was nearly derelict. A leaking roof, cracks in the masonry, heavy overgrowth and loss of wattle panels gave rise to grave concerns for the future of the structure. The Trust commissioned a conservation architect, *Morgan & Horowskyj*, Abergavenny, to undertake a structural survey and the *Royal Commission on the Ancient and Historical Monuments of Wales (RCAHMW)* offered a dendrochronology survey to ascertain the date of the barn's construction.

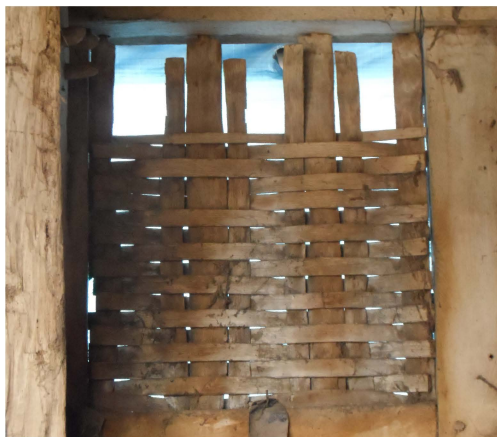
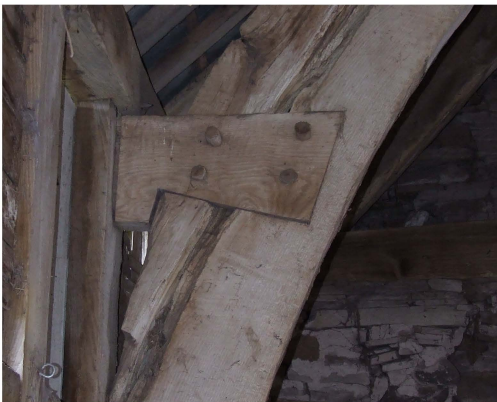
*Above: original wattle panel intact in north wall  
Below: detail of sixteenth century carpentry on eastern cruck-truss.*
